**Outsourced Building Management Services for Northbrook
Public Library**

**Capital Asset Study
Northbrook Public Library
Northbrook, Illinois**

BTC Project No. 19-472
June 14, 2019

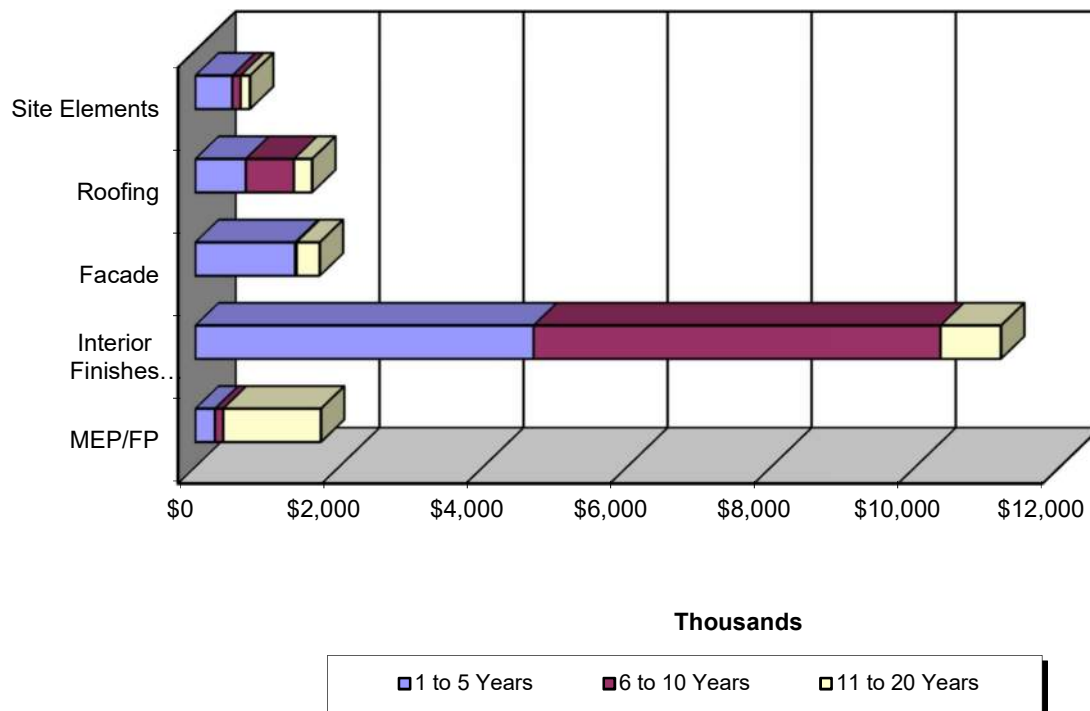
Inflated Capital Expenses over 20 Years

The following bar chart illustrates the expenses that will be incurred for each of the component categories over the 20-year study period. These expenses are divided into 5- and 10-year segments to provide a graphical summary that assists the user in identifying the amount of funding that will be required for each component category over a period of time, whether it is short-term or long-term.

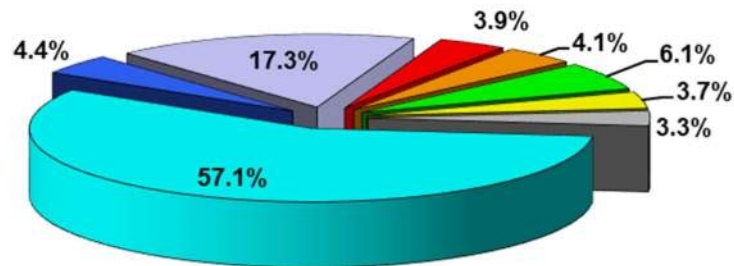
% of Future Expenses Accumulated Over Life of Study

The following pie chart illustrates which components will have the highest percentage of expenses over the 20-year study period.

- Main Roof
- Barreled Roof
- Exterior Facade Repairs
- Flooring
- Technology and Communications
- Master Plan Rehabilitation
- Air Handlers
- Other

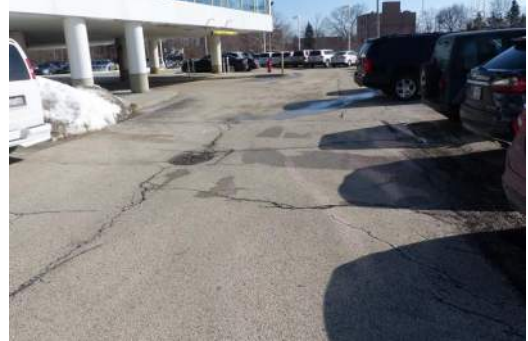
Photo 1

An asphalt pavement parking lot and driveway along the perimeter of the building serve as primary parking areas for library patrons (Photo 1). Some of the parking spaces are located under the 2nd floor overhang (Photo 2). Employees utilize an asphalt pavement parking lot northeast of the Library (Photo 3).

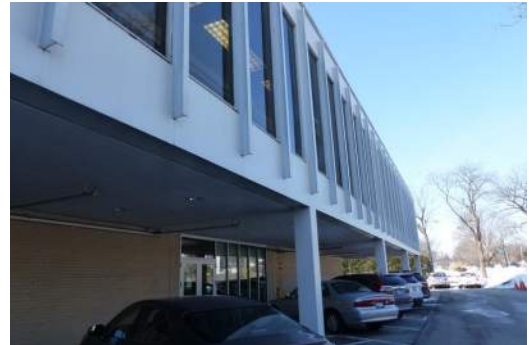
Photo 4

A concrete driveway along the east side of the 1975 expansion provides access to the east entrance to the building (Photo 4).

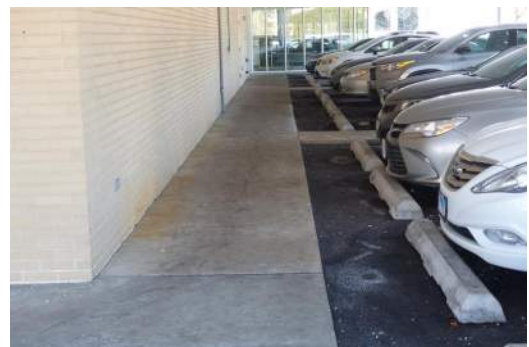
Photo 5

Concrete sidewalks abut the perimeter of the building (Photo 5). A concrete ramp and stairs are located on the west side of the site providing pedestrian access to the west entrance to the Library (Photo 6). The stairs have steel handrails along both sides with railing posts embedded into the concrete. The ramp has aluminum handrails and railings with embedded railing posts. Another set of stairs with steel pipe handrails is located near the northeast corner of the site providing pedestrian access to and from the employee parking lot.

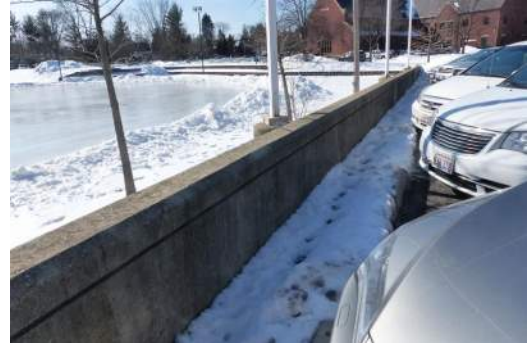
Photo 7

Concrete retaining walls line the ramp on the west side of the site, and the outside perimeter of the parking lot on the east side of the site (Photo 7).

- Replace concrete sidewalk sections as necessary;
- Replace deteriorated sections of concrete curbs as necessary;
- Repair cracks in retaining walls;

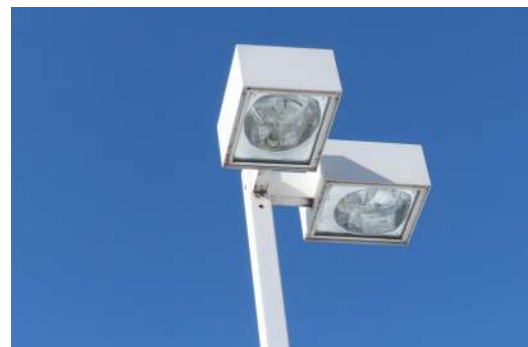
Photo 8

The east parking lot and employee parking lot are illuminated by pole-mounted dual-fixture lights (Photo 8).

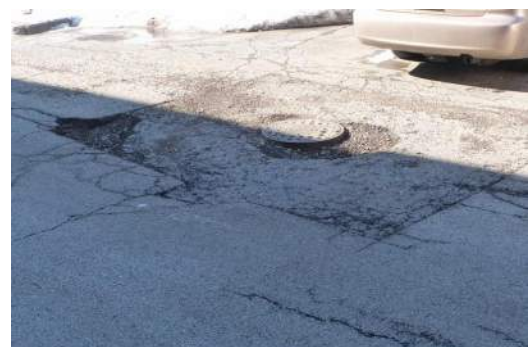
Photo 9

Asphalt Pavement: Asphalt pavement was generally observed to be in poor condition (Photo 9). Wide-spread cracking was observed throughout the paved areas.

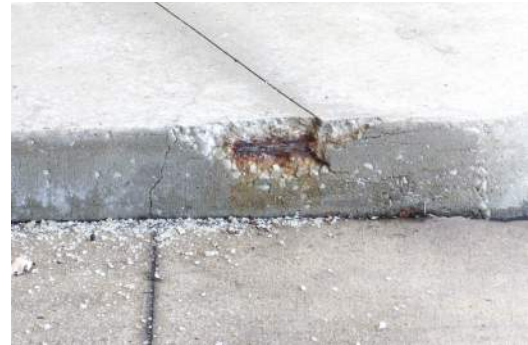
Photo 10

- Cracking;
- Localized spalling (Photo 10);
- Heaved or settled sections;
- Pitting (Photo 11);
- Evidence of corroding reinforcing steel in stairs at west side of site (Photo 12);

Concrete Repairs: Rehabilitation of concrete components throughout can be performed together as a single project. Such rehabilitation will likely consist of the following:

- Localized patch repairs at concrete driveway;
- Replace concrete at west stairs;
- Concrete patch repairs at other stairs as necessary;

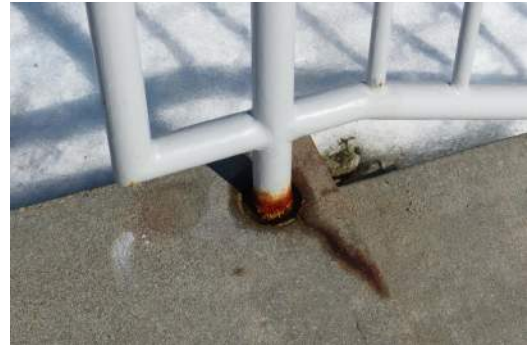
Photo 13

Railings and Handrails: Corrosion was observed at embedded railing posts at the west side stairs (Photo 13). The railings and handrails along the ramp on the west side of the site generally

Embedded railing posts will require more frequent maintenance. We recommend considering surface mounted railing posts when the railings are replaced.

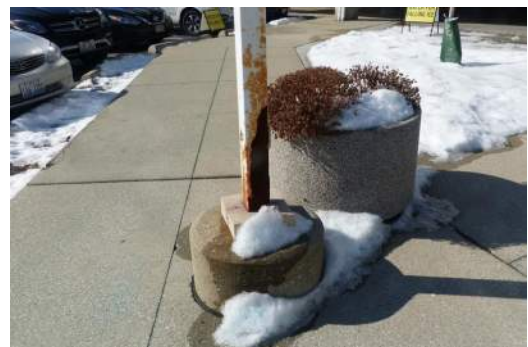
Photo 14

Site Lighting: Pole-mounted light fixtures in the parking lots generally appeared to be in fair condition. Surface corrosion was observed at the base of some light fixtures (Photo 14).

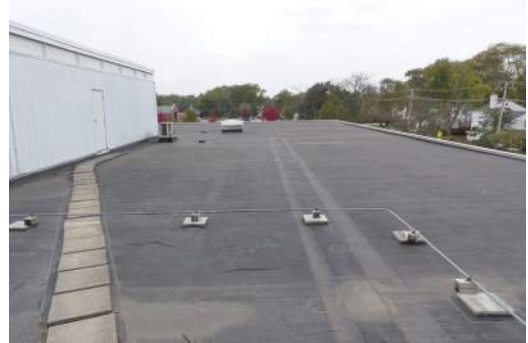
Photo 1

The main low-slope roof consists of an EPDM roofing system (Photo 1). Elevated mechanical platforms and penthouses also have an EPDM roofing system (Photos 2 and 3). A similar EPDM roofing system exists on the barreled roof over the 1999 addition (Photo 4).

- 2023/2024: Replace roofing system at barreled roof
Approximate Cost: \$630,000
- 2025/2026: Replace roofing system at main roof
Approximate Cost: \$575,000
- 2033/2034: Replace roofing system at elevated mechanical platforms/penthouses
Approximate Cost: \$180,000

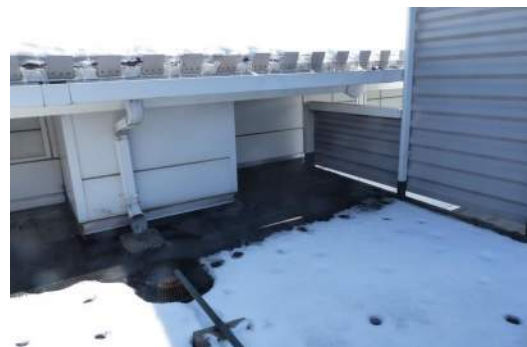
Photo 5

Aluminum gutters are located along the low sides of the barreled roof and at the mechanical penthouse. The gutters deliver water to aluminum downspouts that drain on to the elevated mechanical or main low-slope roofs (Photo 5).

- Continue current program for routine maintenance inspections and repairs.
- Periodically remove debris from roof drains, gutters, and downspouts.
- Clean all drains and ensure they provide unobstructed flow.
- Check all drain screens and ensure that they are secured.

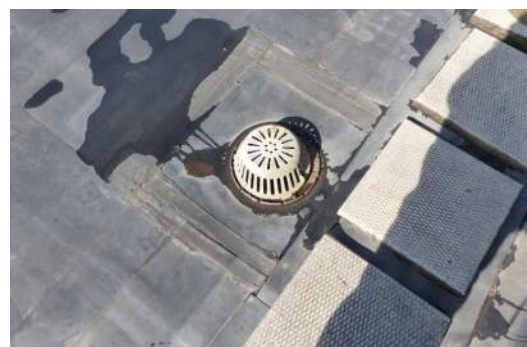
Photo 6

The main roof drains to internal roof drains (Photo 6). The roof membrane is terminated under edge-metal flashing along the outside perimeter of the main roof. The roof membrane is terminated with termination bars at transitions to vertical surfaces such as the mechanical penthouse walls (Photo 7).

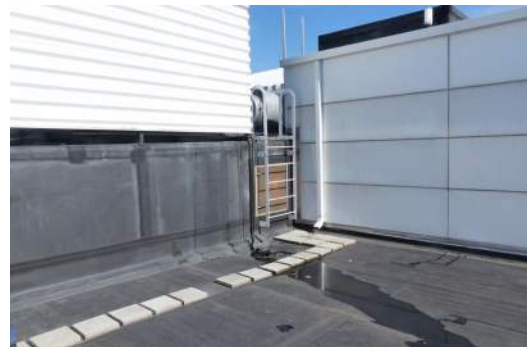
Photo 8

Wall-mounted steel ladders provide access to the elevated mechanical platforms (Photo 8).

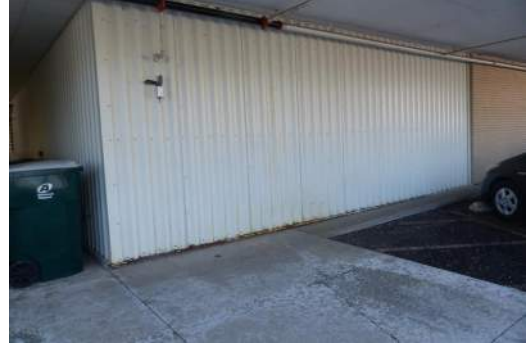
Photo 1

The facade on the 1st floor of the Library consists of a combination of brick masonry, corrugated metal panels, and full-height storefront windows (Photos 1 and 2). Most of the 1st floor facade is set back from the overhanging 2nd floor.

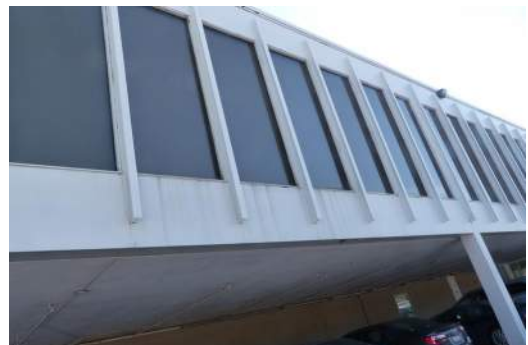
Photo 3

The Library was originally constructed in 1969 and expanded in 1975. The facade on the 2nd floor along the 1969 and 1975 portions of the building consist of floor-to-ceiling steel-framed windows with steel plate spandrel panels above and below (Photo 3).

The Library has reportedly been experiencing water leakage issues at the 2nd floor windows along the 1969/1975 portions of the building. Wiss, Janney, Elstner Associates, Inc. (WJE) performed an up-close review of the windows and metal panel cladding. In their preliminary report dated

December 18, 2018, WJE identified significant deterioration in steel and sealant components that have contributed to the reported leaks. WJE is reportedly preparing a more detailed report with recommendations for repairs.

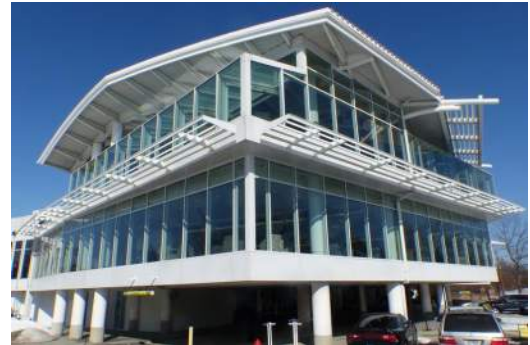
Photo 4

The 2nd and 3rd floor facade along the 1999 expansion consists of an aluminum and glass window wall system (Photo 4). Ornamental louver sunscreen elements project outward at some locations. Portions of the window wall system are sloped (Photo 5).

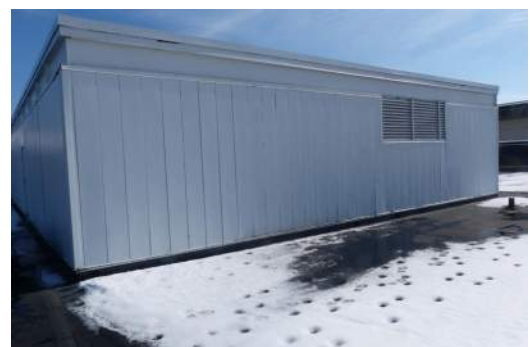
Photo 6

The mechanical penthouse walls and mechanical platform screen walls are clad with metal panels (Photo 6).

Metal panel cladding was exhibiting corrosion at some locations (Photo 10). Corrosion observed at the base of corrugated metal panel cladding on the 1st floor may be related to prolonged exposure to moisture such as standing water. Evidence of corrosion was also observed at other exposed steel components (Photo 11). Chipped paint and debonded sealant were observed at the penthouse wall cladding. Significant leaks have been reported behind and below the metal panels. In order to address this, both Product Architecture and Pepper Construction have recommended replacing the penthouse wall cladding.

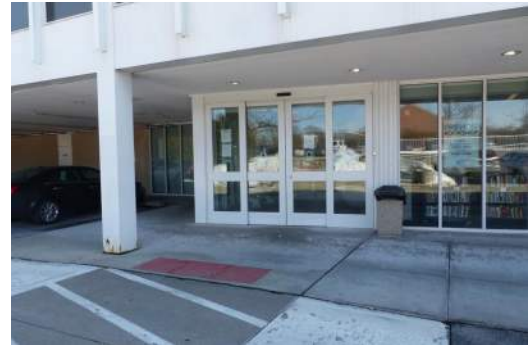
Photo 7

The main entrance on the west side of the building has 2 sets of automatic sliding storefront doors (Photo 7). A similar configuration exists on the east side. Other doors are outswing storefront or steel doors used by employees or for emergencies only.

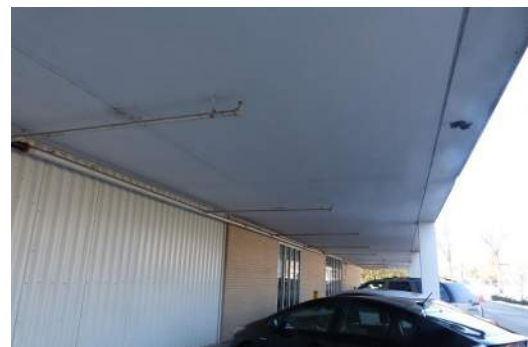
Photo 8

Soffits along the underside of the 2nd floor overhangs have an exterior plaster finish on the north, south, and west sides of the building (Photo 8). The soffit over the concrete driveway along the east side of the building is finished with ceiling tiles.

- Miscellaneous masonry repairs including repointing deteriorated mortar joints, replacement of expansion joint sealant, routing and sealing cracks, etc.;
- Replacement of glazing sealant and gaskets;
- Repair deteriorated soffit finishes. This may require localized patching at some locations. Other locations may require replacing entire panels.
- Remove corrosion products and recoat exposed steel components.

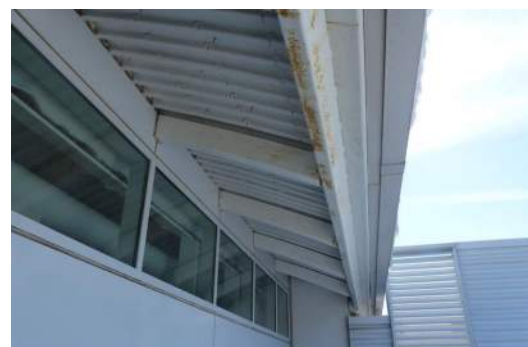
Photo 9

- Vertically oriented ornamental steel wide flange sections between 2nd floor windows;
- Columns supporting the 2nd floor overhangs;
- Underside of 1999 addition barreled roof overhangs (Photo 9)

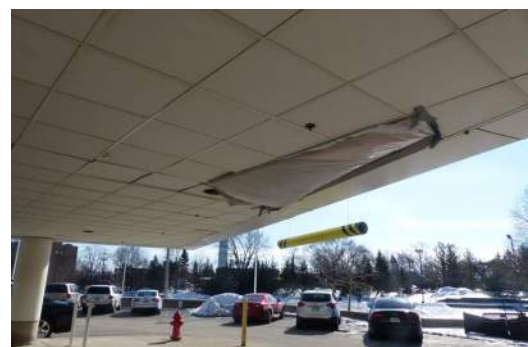
Photo 12

Soffits at the 1st floor were generally in fair condition along the north and west elevations. Missing, damaged, or dislodged ceiling tiles were observed at the soffit along the east elevation (Photo 12).

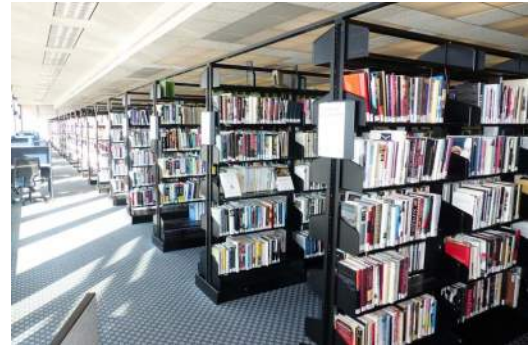
Photo 7

- Non-fiction (Photo 7)
- Main Street
- Atriums One and Two (Photo 8)
- Quiet study rooms (Photo 9)
- Interactive classroom (Photo 10)
- Collaboratory (Photo 11)
- Staff offices
- Restrooms

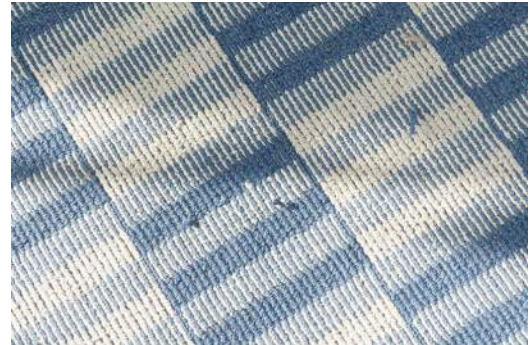
Photo 13

Flooring: Much of the carpeting was replaced during the 2015 auditorium addition and interior remodeling project. The carpeting on all 3 levels was generally in fair condition. Localized wearing was observed in high traffic areas (Photo 13).

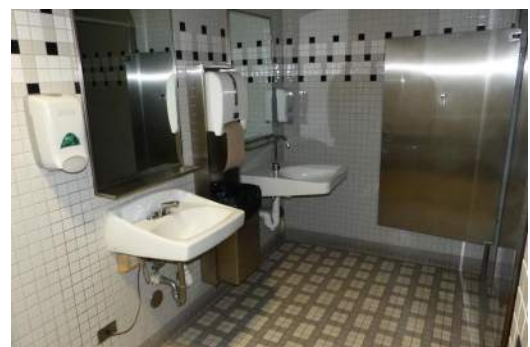
Photo 14

Restroom Finishes and Fixtures: The public restroom on the 1st floor were rehabilitated in 2015 and are generally in good condition (Photo 14). The finishes and fixtures in the 2nd and 3rd floor restrooms are assumed to be several years older but appeared to be in good condition as well (Photo 15).

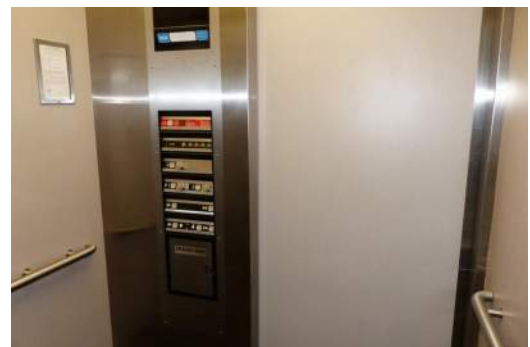
Photo 16

Elevator Finishes and Controls: The elevators were added with the 3rd floor addition in 1998. The elevators appeared to be operating well and the cab finishes were generally in fair condition (Photos 16 and).

- 2028/2029: Elevator cab refurbishment
Approximate Cost: \$50,000
- 2029/2030:
 - Replace 1st floor carpeting
Approximate Cost: \$96,000
 - Allowance for furniture and shelving
Approximate Cost: \$50,000

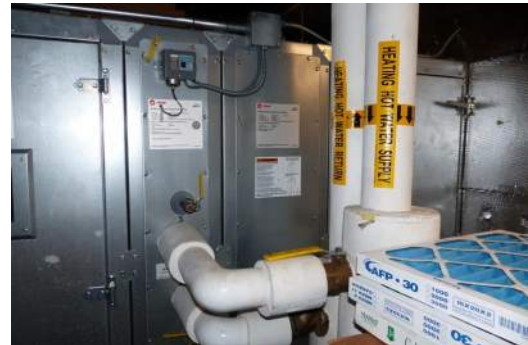
Photo 1

- Air handlers: 5 each (Photos 1 and 2)
- Roof-top units (RTUs): 2 each (Photo 3)
- Split-system air conditioners: 4 each (Photo 4)
- Chiller (Photo 5)
- Cooling tower
- Boilers: 3 each (Photo 6)
- HVAC pumps: 17 each (Photo 7)
- Exhaust fans: 15 each (Photo 8)
- Fire pump (Photo 9)
- Domestic water heater
- Sewage ejector pump: 2 each
- Sump pumps: 2 each (Photo 10)
- Emergency generator (Photo 11)
- Temperature control air compressors: 2 each

Most of the air handling units have either been replaced or rehabilitated in recent years. Air Handling Unit S-3A was installed in 1968 during the original construction of the Library. The Calor

report recommended replacement in 2024. However, based on conversations with Library staff regarding the performance of the equipment, replacement is recommended sooner.

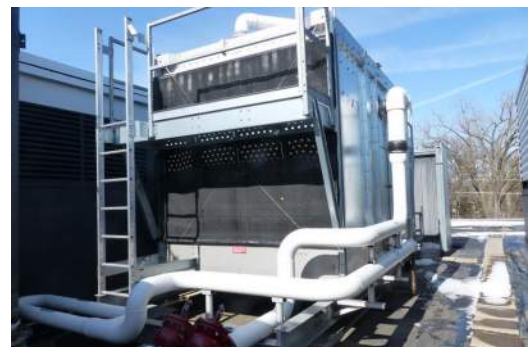
Photo 5

Chiller C-1 (used as a back-up for Chiller C-2) Cooling Tower CT-2 were removed in 2016. Chiller C-2 was repaired, and the corresponding Cooling Tower CT-2 was replaced in 2018.
